**Plexipave[®]**

CRACK REPAIR AT A
PRIVATE COURT IN MONTENEGRO

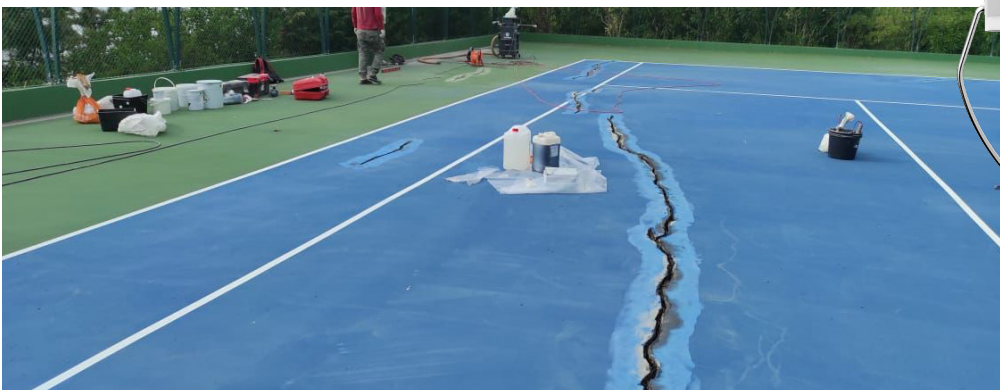
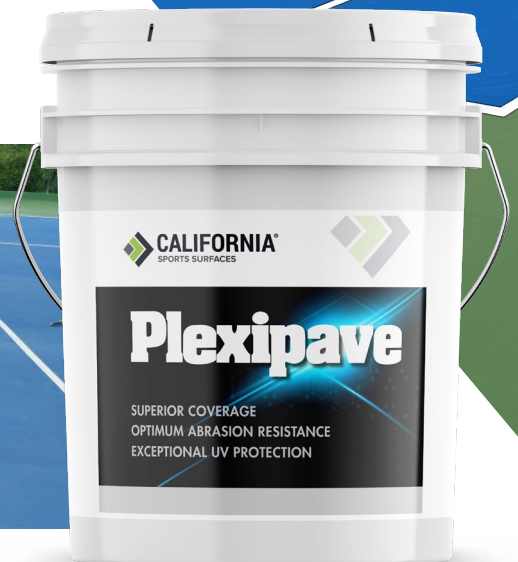
A private sport court in Reževići experienced persistent structural cracking caused by construction-related subsidence and foundational instability. The cracks were visible not only on the asphalt surface but also on adjacent concrete retaining walls, highlighting the severity of the issue. Over the years, multiple repair methods were trialed—without lasting success. These included:

- **Court Patch Binder** – Provided only temporary repair before cracks reappeared.
- **Two-component PU adhesive** – While flexible, it led to surface issues due to seasonal temperature fluctuations: the adhesive would depress in cold weather and rise above the surface in heat, causing visible distortion and performance concerns.

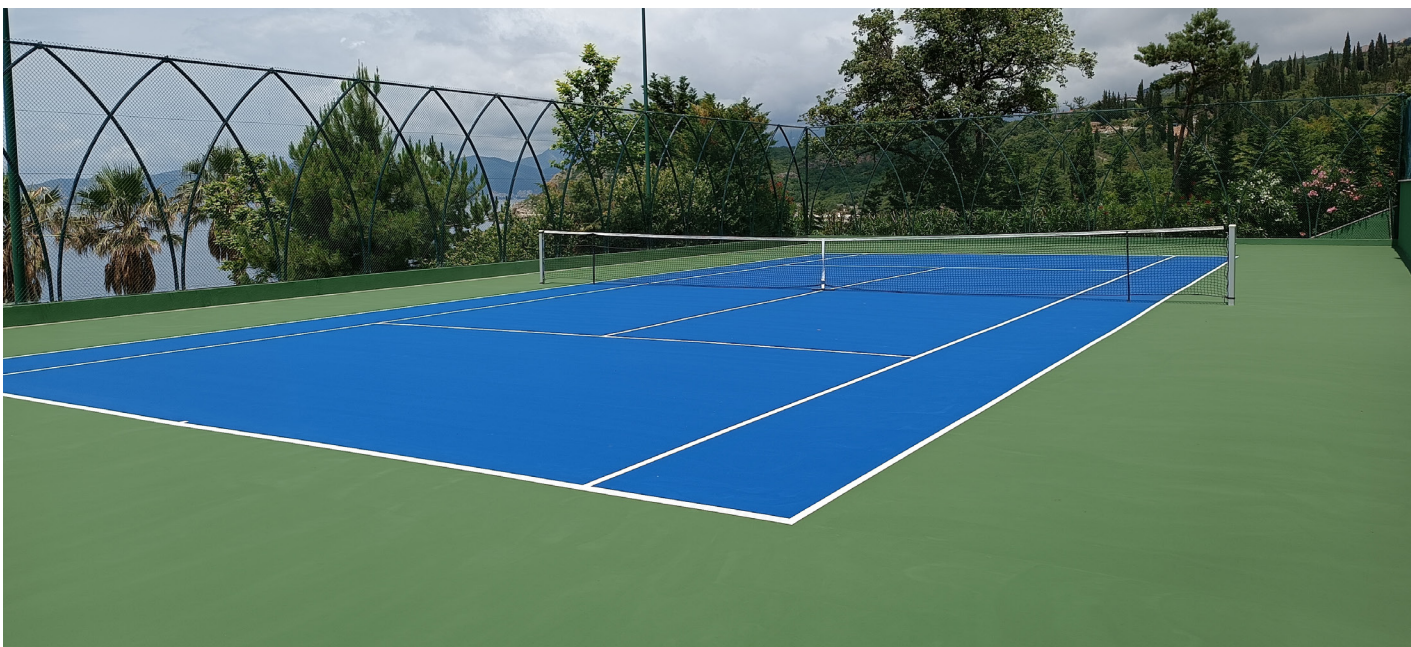
A second technique was tested on a separate client's court where old asphalt had been patched with new material—another known weak point where cracking occurs.

1. **Tape Isolation Method:** The junction between new and old asphalt was covered with tape bonded only along the crack using two-component PU adhesive. A 2 cm margin on either side was left unglued so the tape could “float,” minimizing stress transmission to the acrylic surface above.
2. **Finish:** Several coats of AR were applied over the tape, followed by full-court resurfacing.
