CASE STUDY

BELGRADE, SERBIA

CRACK REPAIR AT A PRIVATE COURT IN BELGRADE

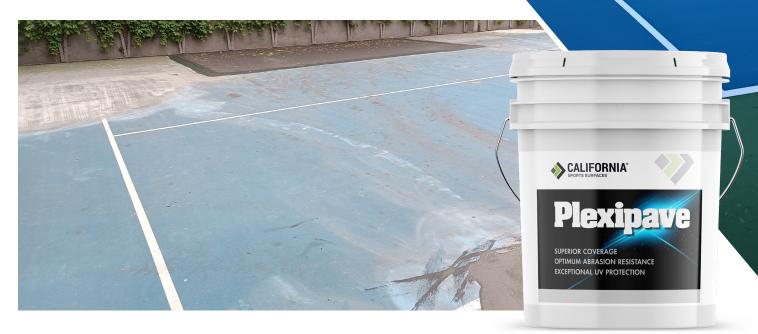
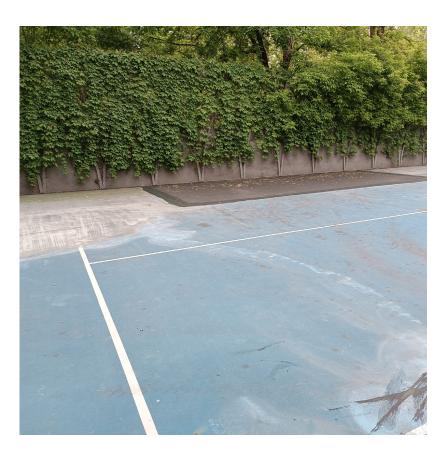
This private sport court in Belgrade presented a unique challenge: extensive surface cracking and heavy deviations in the asphalt, with no clearly identified cause. Potential contributing factors include underground water movement, invasive tree roots, or a combination of both.

- 1. Crack Isolation with Tape: Thin rubberreinforced tape was applied directly over cracks to bridge movement-prone areas. This technique allows the tape to absorb stress and reduce the risk of crack telegraphing into the acrylic top layers.
- 2. Leveling with AR Mix: Two coats of AR (Acrylic Resurfacer) were applied over the taped sections, using a mix of AR, silica sand, and water to provide a uniform texture and embed the tape beneath the surface.
- 3. Full Resurfacing: The court was completed with two coats of Plexipave Ultra Performance color, mixed with sand-filled Color Base, CSS's standard water-based surface system, offering long-term durability and performance for recreational use.

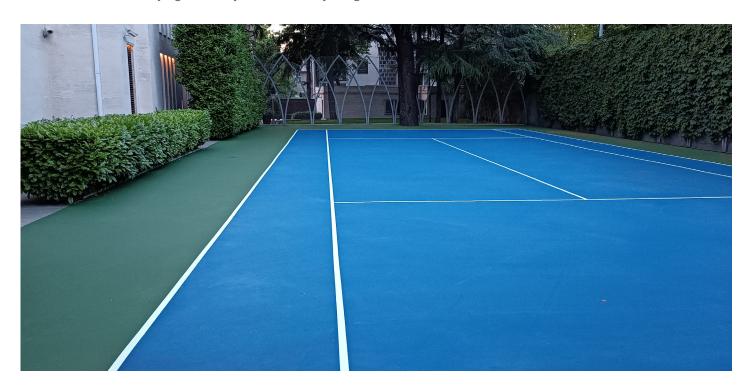
As of the latest update, the repaired areas remain intact, with no return of visible cracking or deformation. The rubberreinforced tape approach provided an effective buffer against substrate movement, making it a promising method for situations where underlying instability cannot be fully mitigated.
